## **Technical Bulletin**

Model 911 C2/C4/T

Fan Bearing Drive/Belt Damage

Number 9301

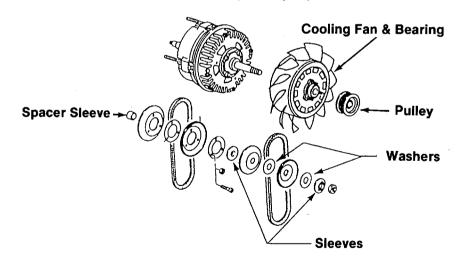
Description	Part Number	Production
Pulley	930 106 124 02 (formerly 01)	8/26/92
Spacer sleeve	964 106 515 01 (formerly 00)	8 /24 /92

A damaged engine cooling fan bearing can cause the attached parts to run at higher than normal temperatures. Whenever the cooling fan bearing is found to be faulty, the following parts should also be replaced along with any visibly damaged parts.
